Toth and Associates Environmental Services

Re: Assessment of a watercourse on 1441 Fisher Road (PID# 006-831-231).

1.0 INTRODUCTION

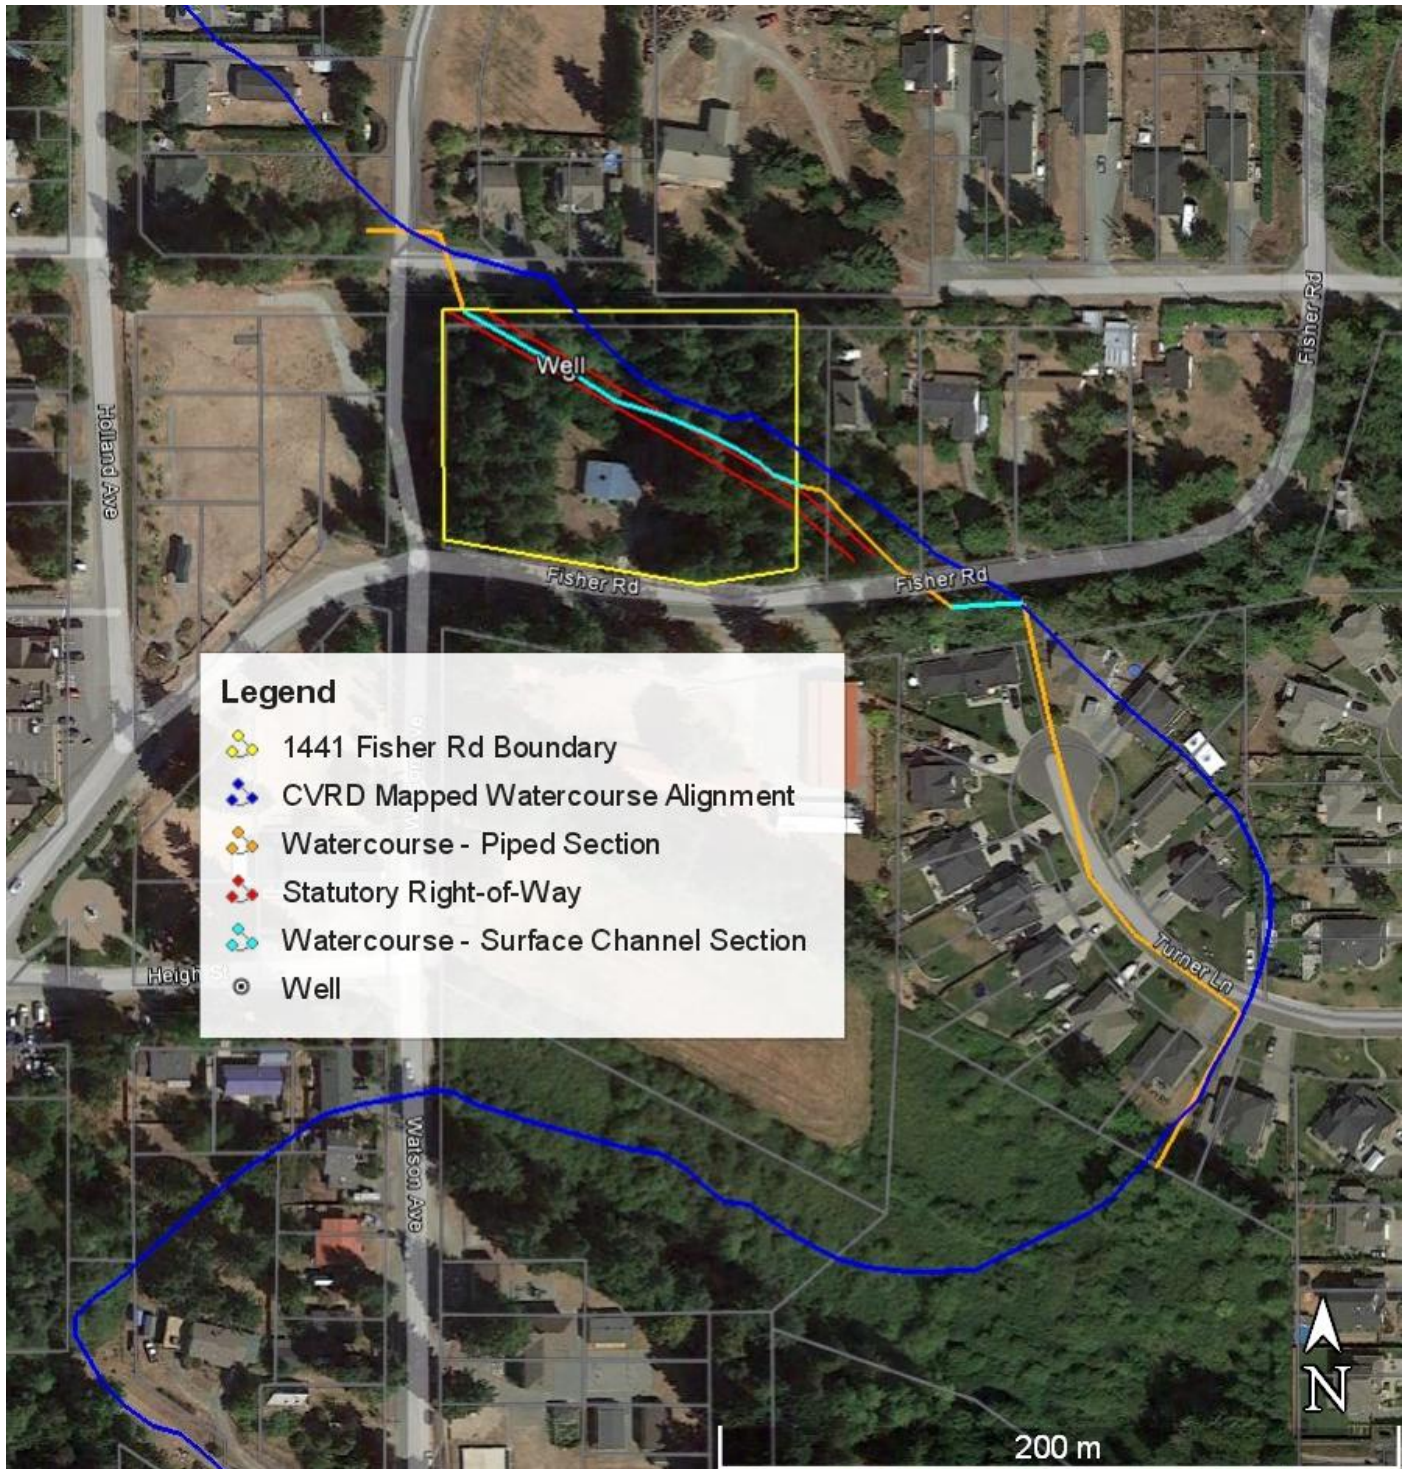
Figure 1. Overview of existing and mapped streamlines

The CVRD’s Webmap indicates a stream running northwest to southeast across the subject property and a statutory right-of-way (SRW) running on this same approximate alignment (Figure 1).

The watercourse through the subject property does not support fish. The watercourse downstream of Fisher Road appears to be contained within a storm drain system for approximately 193 m before discharging to a wetland area in Watson Park. As the CVRD does not provide storm sewer network mapping, the alignment shown for the storm drain downstream of Fisher Road through the Twin Cedars development is approximate and was based on manhole and catch-basin locations.

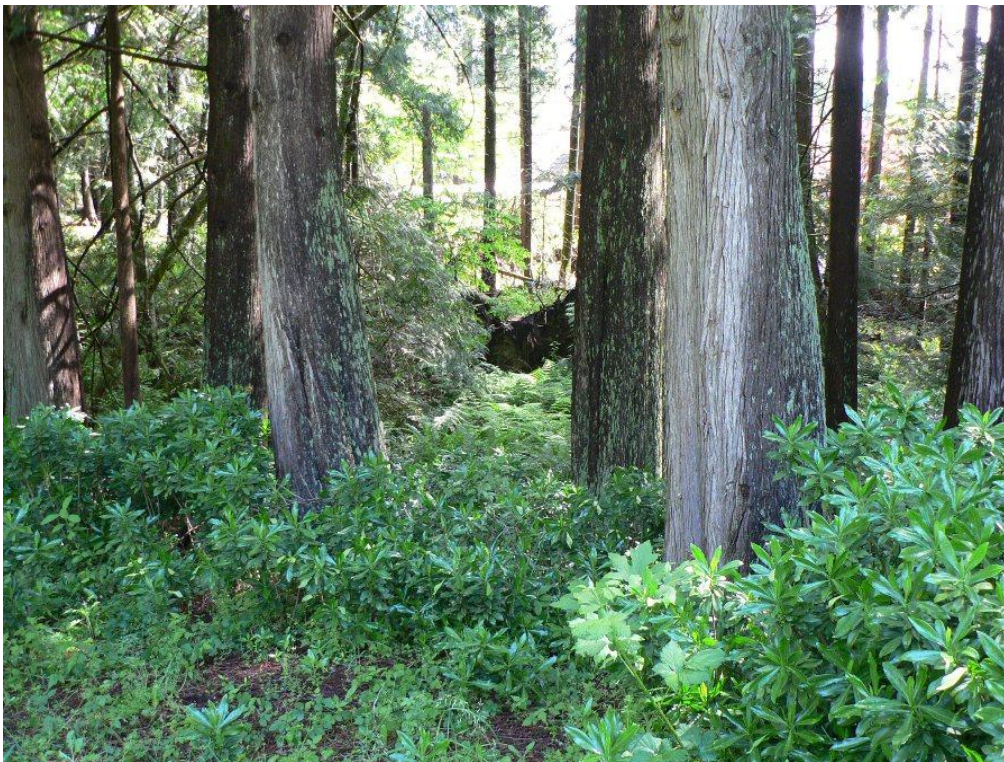
Photograph 4. View of mature western redcedars with spurge laurel.

During development, all reasonable attempts should be made to eradicate invasive plant species on the subject property. Gloves should be worn when handling spurge laurel as it is caustic.

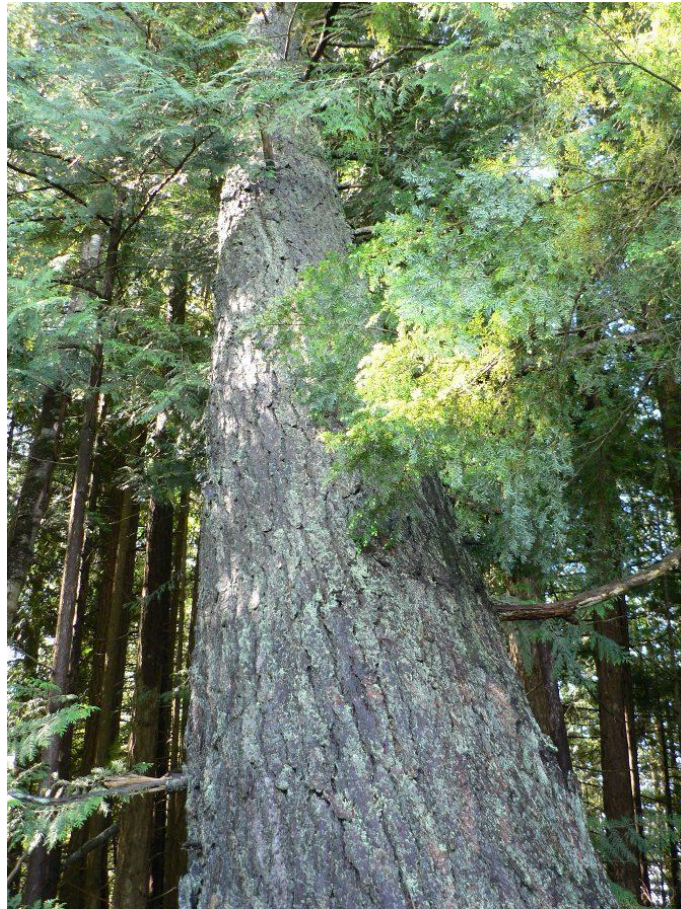
Tree failure was noted in a couple of locations and appeared to be related to saturated root zones / storm events (Photograph 5). Overall the forested area consists of a relatively open setting of mature western redcedars with lush seasonal herb layer growth.

Photograph 5. View of partially fallen large diameter western hemlock on the property.

As indicated previously, the majority of the property is forested with mature trees. Those trees in close proximity to the watercourse are located in saturated soils and will be prone to windthrow if the remainder of the property is cleared. Retention of mature trees within the watercourse setbacks would likely lead to significant windthrow and we would recommend that these trees be removed and replaced with seedling native trees.

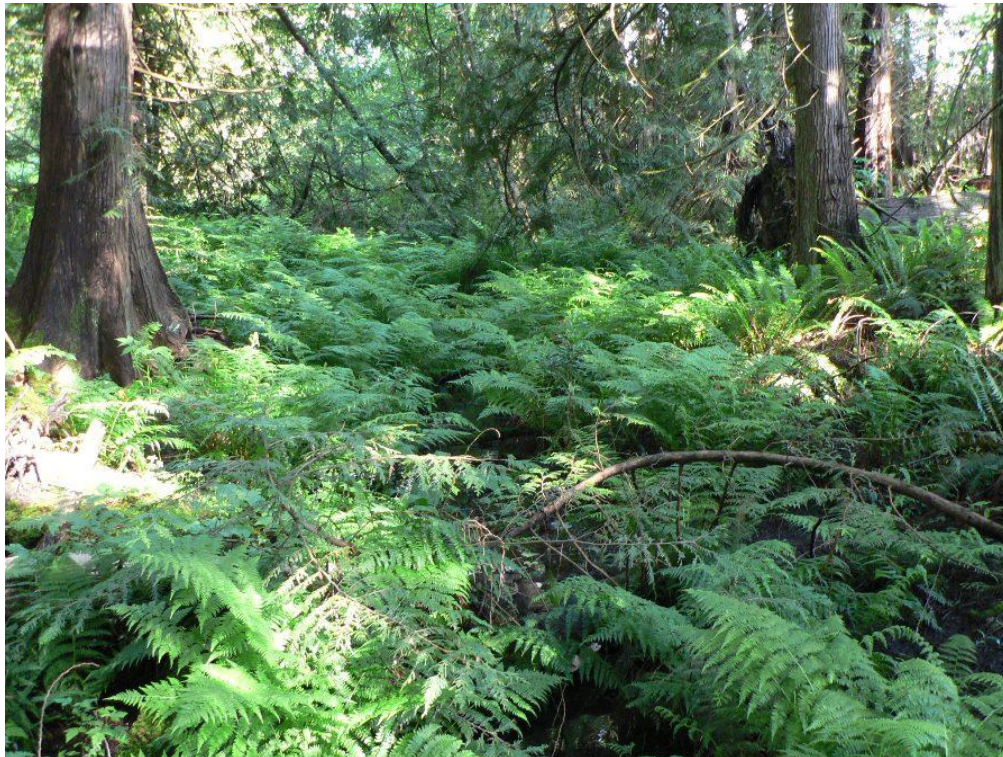
The watercourse through the property consists of an approximately 1 m wide stream with low banks and muck substrates (Photographs 6 & 7). The winter channel width averages approximately 2.5 m. Channel gradient is approximately 1%. The channel is relatively uniform in width and format through the property, with no pools, riffles or habitat complexity. No fish, amphibians or other aquatic life were observed in the watercourse. An old well is located in the stream channel (Photograph 8).

Photograph 6. View upstream on the watercourse.

In consideration of the relatively low habitat values associated with the remaining length of open channel through the subject property and if placing the watercourse in a storm drain is not an option, we would consider a variance application for a reduction in the watercourse setbacks required under the CVRD's Zoning Bylaw appropriate. As a comparison to the CVRD's 15 m watercourse setbacks, under the RAPR non fish bearing ditches receive 2 m setbacks and modified natural watercourses <3.3m average channel width receive 10 m setbacks.

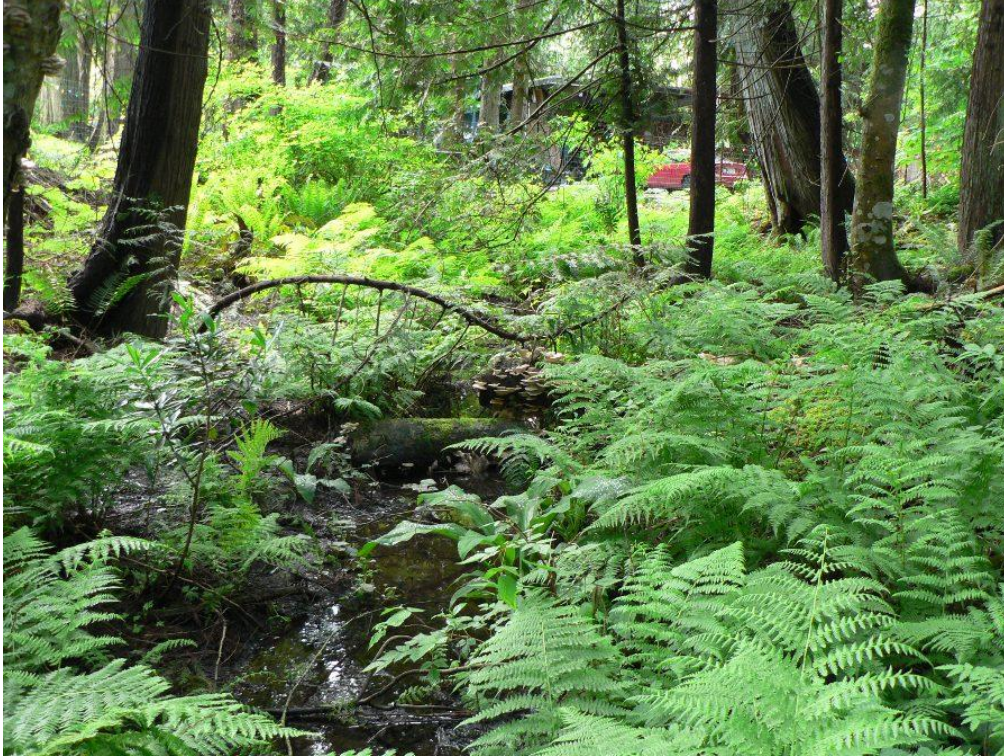
Photograph 7. View downstream on the watercourse.

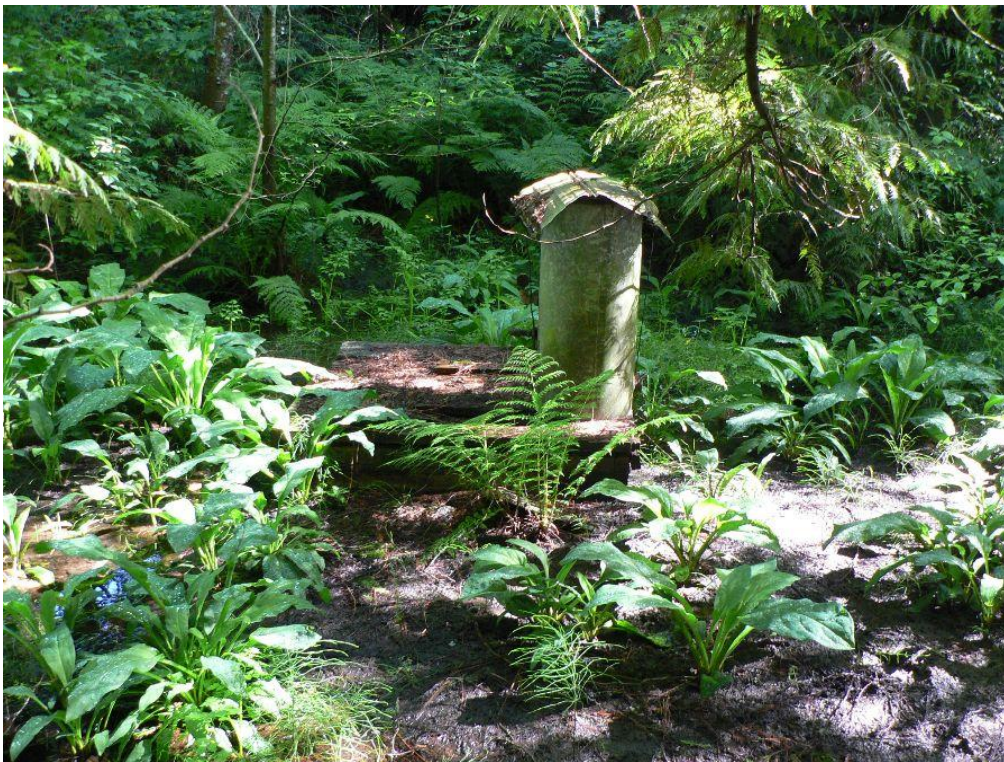
Photograph 8. View of old well in the stream channel.
