RE: 3450 Trans - Canada Highway, Cobble Hill, BC – Overview Ecological Assessment

Site Photos

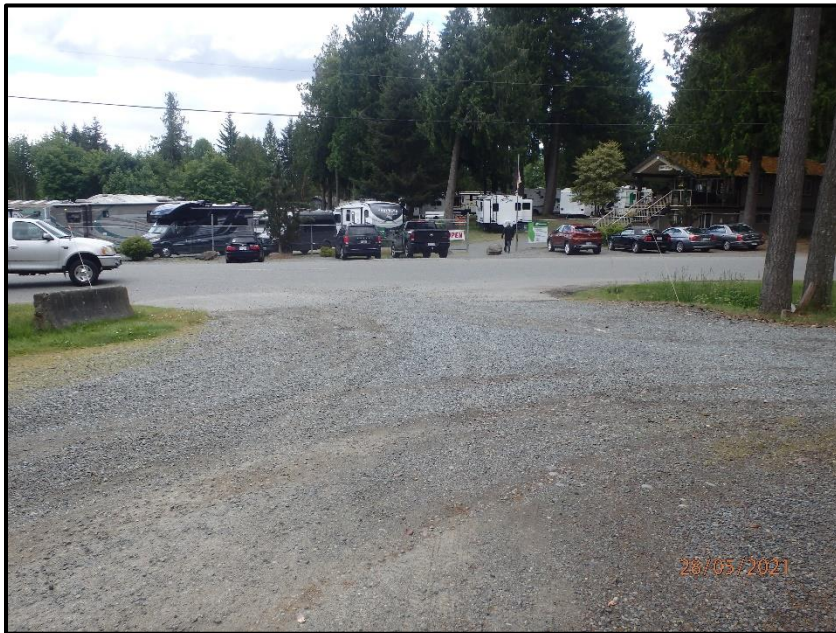
Looking south at the entrance to the subject property. This access extends off Chapman Road and leads to the area that is used by employees for parking.

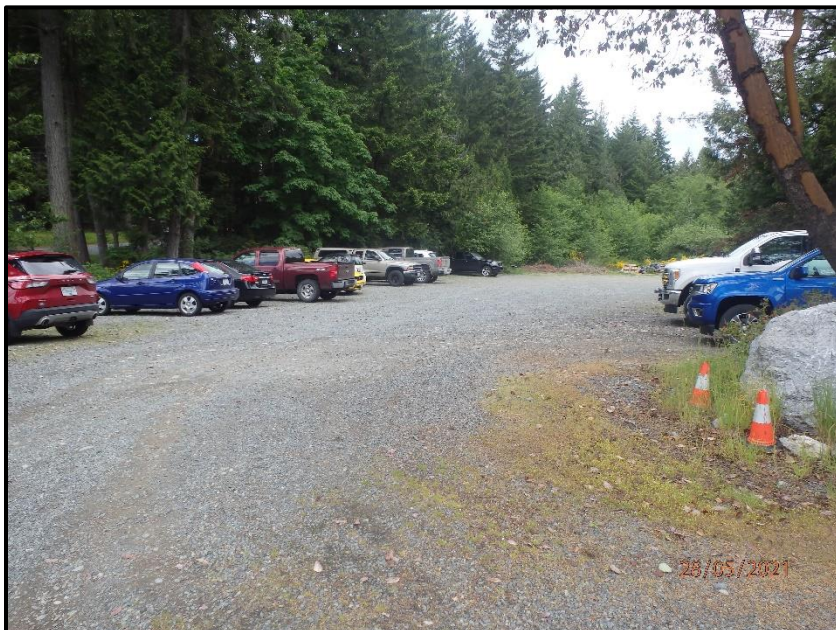
A photo showing the western portion of the parking area.

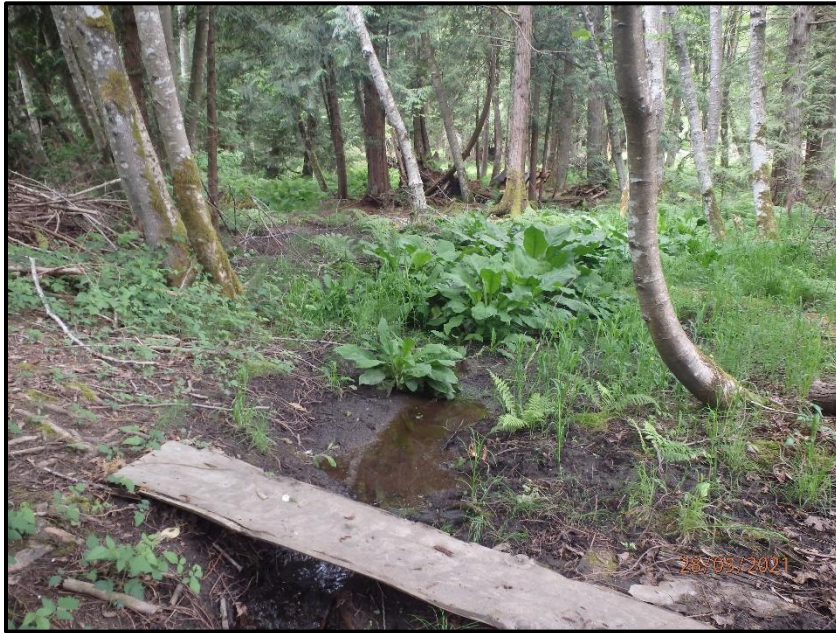
Looking upstream (northwest) at the inlet drainage of the pond that is located in the northwest corner of the property. This piece of the drainage is located on the adjacent property to the northwest. Note that this feature has characteristics (skunk cabbage and organic substrate) that are typical of a swamp ecosystem.

An inlet drainage flows from the property to the north and into the pond. At the southern end of the pond, an outlet drainage directs water subsurface through a series of pipes for the entire length of the property. The flow of water then discharges into the roadside ditch adjacent to Chapman Road. The flow of water continues under Chapman Road and down the Trans-Canada Highway.

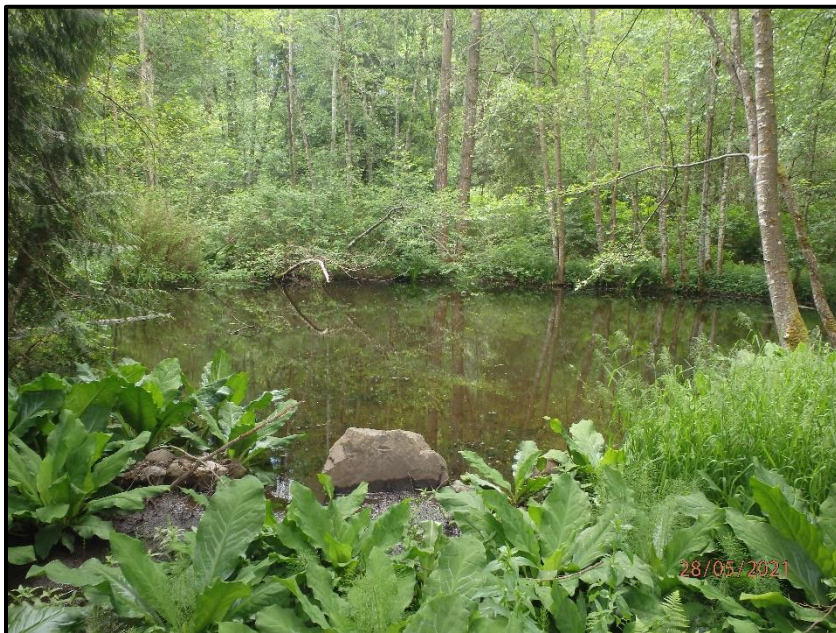
Looking west at the pond that is positioned in the northwest corner of the lot.

In the northwest corner of the lot there is a pond that is about 20 m wide and 30 m long. It was not possible to gain an exact depth of the pond, but based on visibility, it appeared the water was about 1-2 m deep at the time of the assessment. The substrate in the pond is composed entirely of organic materials (decomposing wood and leaf debris). Adjacent to the pond the riparian zone is composed of a young, mixed species (coniferous and deciduous) forest. Tree species include Douglas-fir (*Pseudotsuga menziesii*), western redcedar (*Thuja plicata*) and red alder (*Alnus rubra*). Salmonberry (*Rubus spectabilis*) and willows (*Salix spp.*) are the most abundant shrub species. Herb growth is abundant and composed mostly of skunk cabbage (*Lysichiton americanus*), sedges (*Carex spp.*) and common horsetail (*Equisetum arvense*).

Although the RAPR process does not apply, it is still important to afford protection to the pond. The pond has no fisheries values, but it does represent important wildlife values and will be used by multiple species for foraging and breeding (especially amphibians). The immediate riparian zone is also likely used by various species of migratory birds for breeding. At the time of the assessment there was an abundance of bird activity within the area immediately adjacent the pond. To protect the ecological integrity of the pond ecosystem, it is recommended to incorporate a 15 m no development buffer zone (measured from the High Water Mark - HWM) around the pond. This recommendation is based on general recommendations made in CVRD OCPs to continually identify and protect Ecologically Sensitive Areas. Incorporating a 15 m buffer allows for the pond to be protected, but also allows for future development to take place on the property. This 15 m no development zone includes no deposition of soil, rock or any other materials.

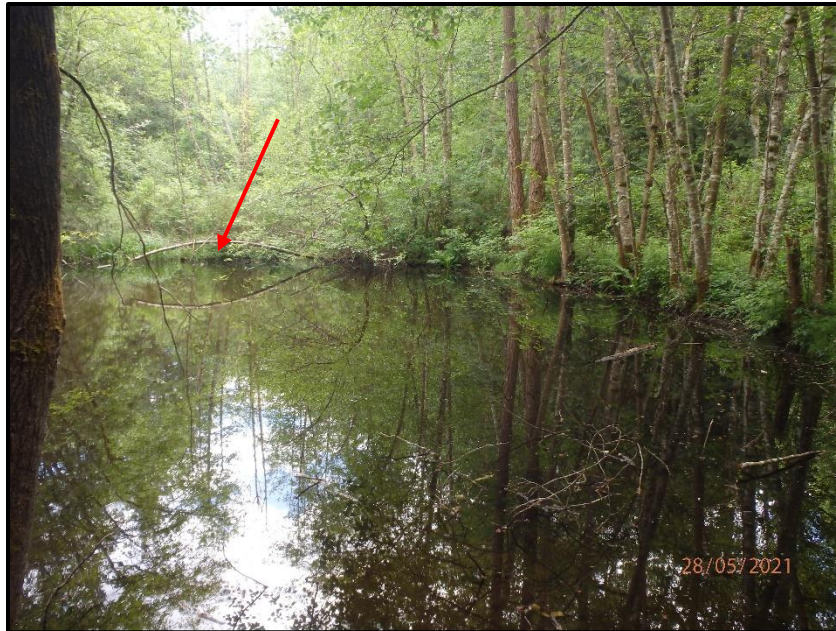
Looking south over the pond. The red arrow marks the approximate location of the outlet drainage.

Section 24.4.10A does not apply as the pond and its outlet drainage are not subject to the provincial RAPR process. However, based on the fact the pond will provide habitat for various species of wildlife, protection measures should be applied. To adequately protect the pond, a 15 m no development zone should be applied, extending from the HWM.

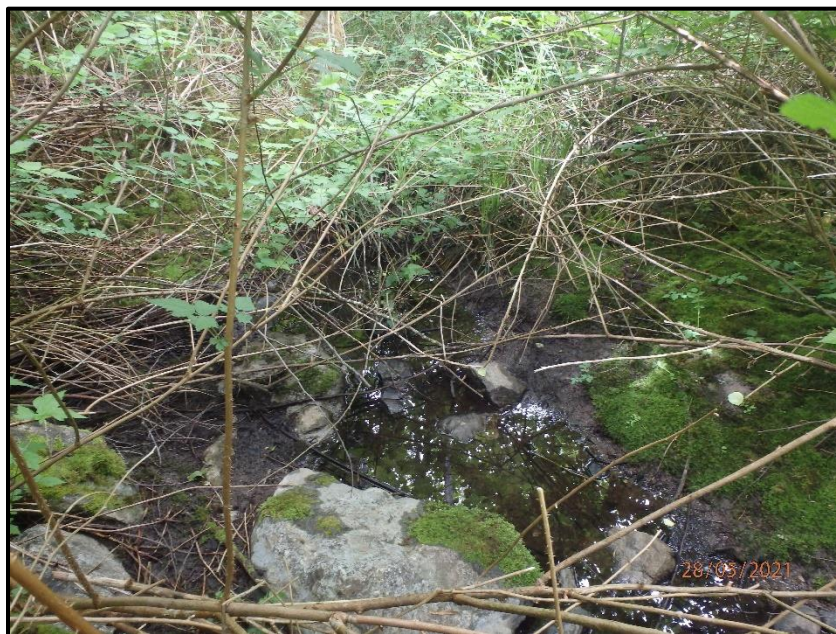
Looking upstream at the drainage that flows out of the pond. This section of the channel is about 5 m below the pond.

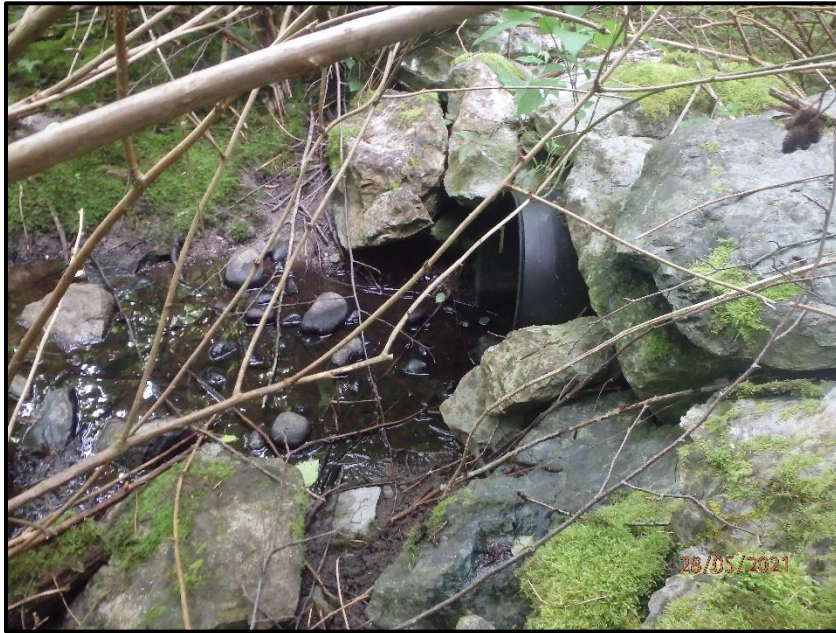
A photo of the culvert that conveys water from the outlet drainage subsurface. From this point the flow of water is entirely underground until it reaches the roadside ditch adjacent to Chapman Road.

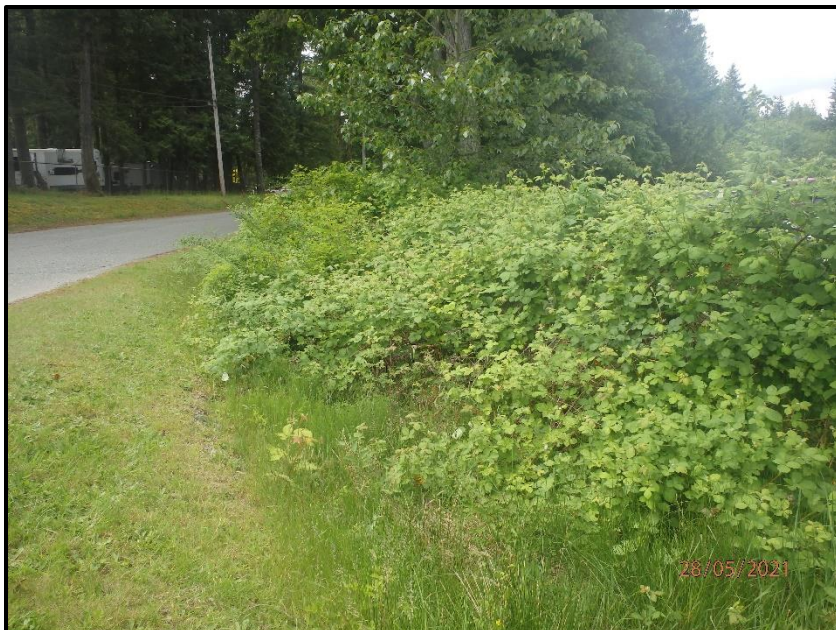
Looking upstream at the section of ditch that runs along Chapman Road, west of the property entrance. As can be seen in the photo the channel is fully overgrown with grasses and Himalayan blackberry.

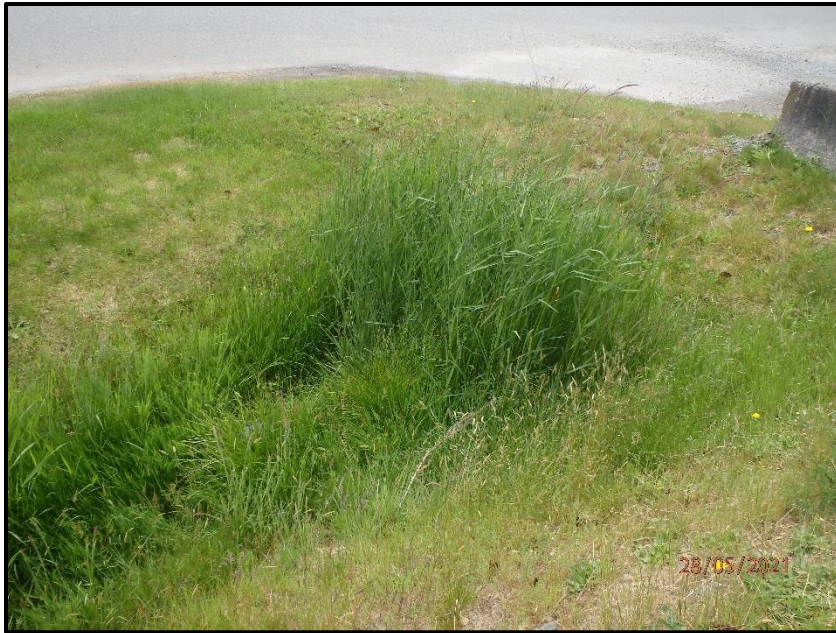
Looking down at the point near the property entrance where the ditch continues.

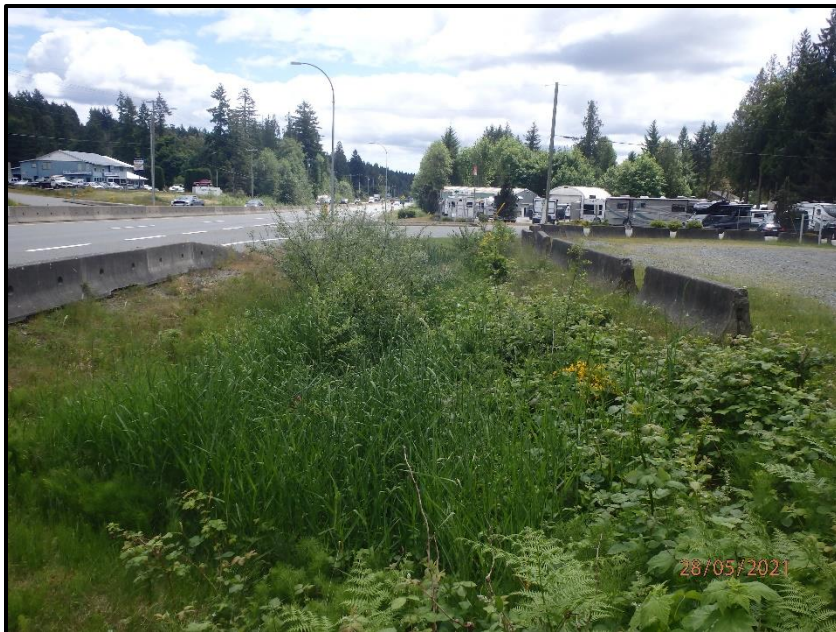
Looking southeast (downstream) at the ditch that runs immediately adjacent to the Trans-Canada Highway.

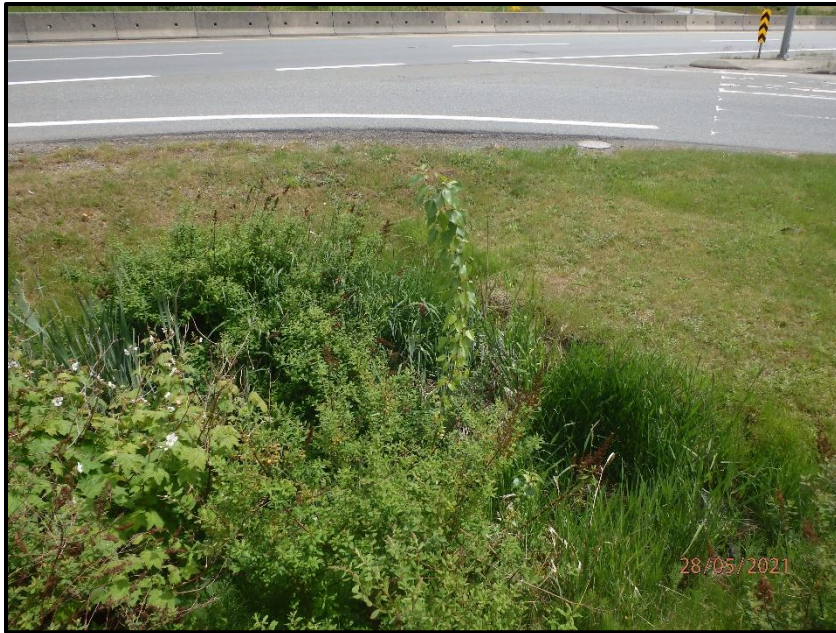
Looking down at the point where the ditches running along Chapman Road and the Trans-Canada Highway converge. From this point, the flow of water is conveyed under Chapman Road and continues south along the highway.

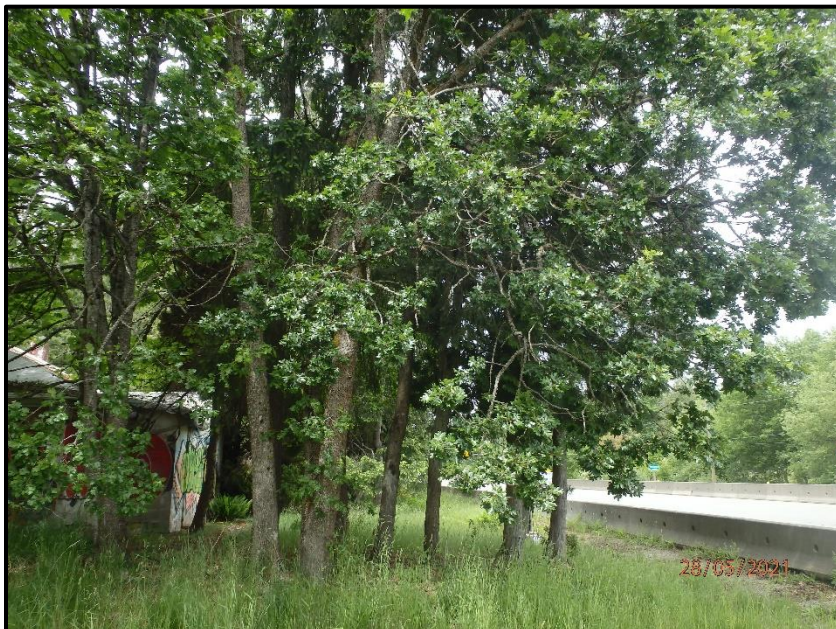
A photo showing a group of Garry oak trees that are located in the east-central portion of the property, immediately adjacent to the Trans-Canada Highway. These trees should be conserved.

Because this proposal is for rezoning, no other development plans have been finalized. However, as strategies for future construction are put together, the project should be planned to retain as many trees along the northern and western boundaries of the property as possible. By retaining trees, it will help to meet landscaping requirements that will be laid out by the CVRD. Trees are not only valuable from an ecological perspective, but also provide ecosystem services that are important to humans such as temperature regulation, wind buffering, soil stabilization and aesthetic value.

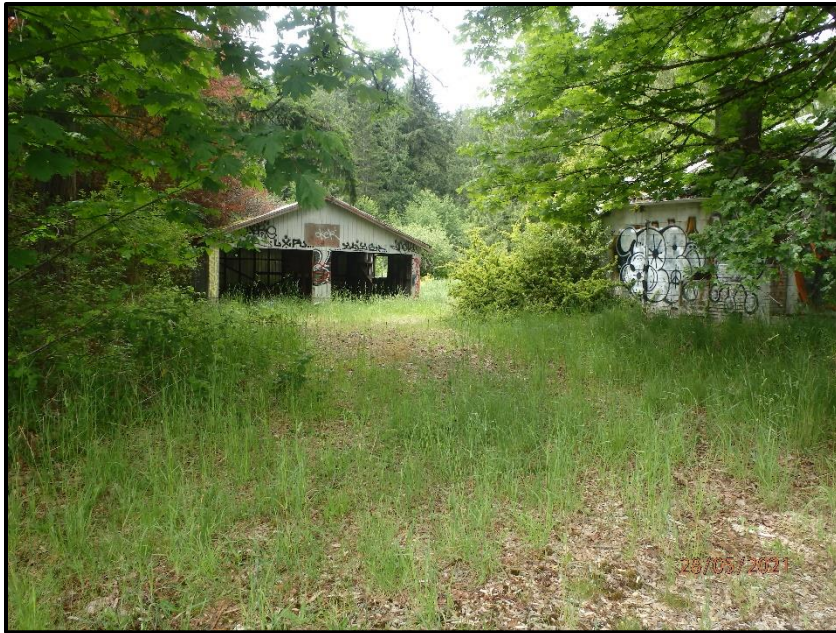
Old buildings located in the east-central portion of the property. The southern half of the property has been subject to a significant amount of disturbance.

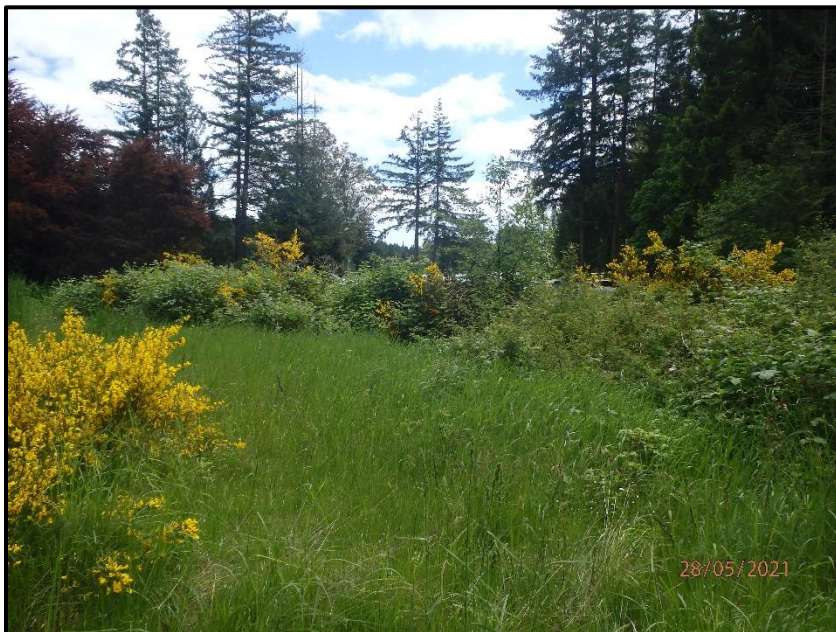
A representative photo of invasive plant growth that exists on the property. The majority of these invasive species occur in the central portion of the property.

Scotch Broom and Himalayan Blackberry are present in the central portion of the subject property adjacent to the old buildings and throughout areas that were previously disturbed. When land clearing and construction occur in the future, this area of plant establishment will be removed by heavy machinery as part of site preparation activities. This vegetation is considered ground cover and, therefore, removal must comply with breeding bird protection protocols. In recognition of expected long-term management of invasive species on the property in areas that are beyond the footprints associated with proposed buildings, roads, and parking areas (e.g., landscaped parts of the property), the following invasive plant management will be required in the future:

Larger Scotch broom plants (i.e., larger than the diameter of a pencil) should be cut, although care must be taken to make the cut below the soil/root interface to avoid vigorous re-sprouting of the plant. If larger plants are pulled out of the ground, soil disturbance will bring more broom seeds to the surface and will encourage seed germination. Smaller broom plants (i.e., less than the diameter of a pencil) can be pulled out of the ground, but soil disturbance must be kept to a minimum.

In order to remove seedlings and mature plants, hand pulling and weed wrenches should be used. Removal should be carried out when the plant is flowering before seeds set. At this time, the plant is more susceptible, as energy reserves are being directed to flowering stems. To minimize re-sprouting, as much of the root system as possible must be removed. Plants that are older and established should be cut using tools such as

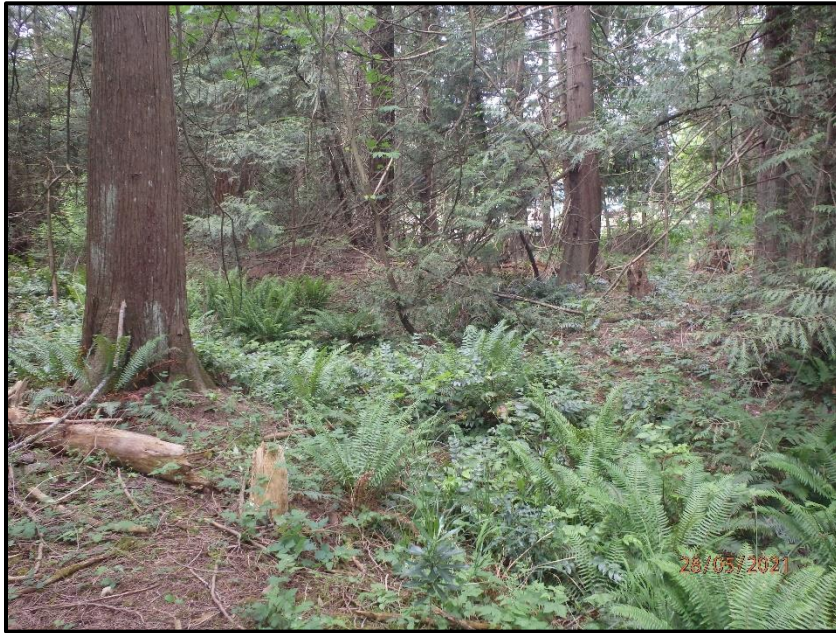
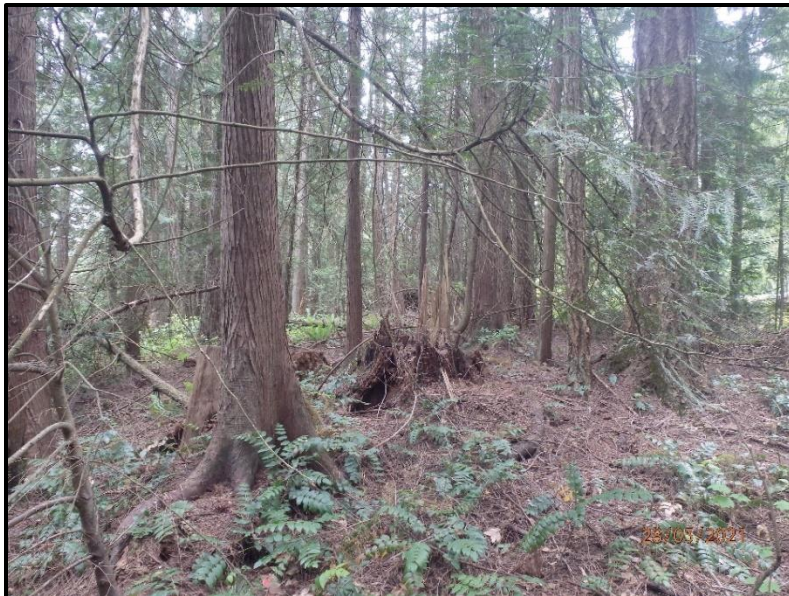
Above and Below: Representative photos of the mature forested ecosystems that span the northern and southwestern boundaries of the property. No invasive species occur in these forested areas.
