## **AQUIFER PROTECTION PLAN**

**3450 Trans-Canada Highway, Cobble Hill, BC  
[PID 000-033-057]**

**May 23, 2023**

DOSSIER: 23.0037-001

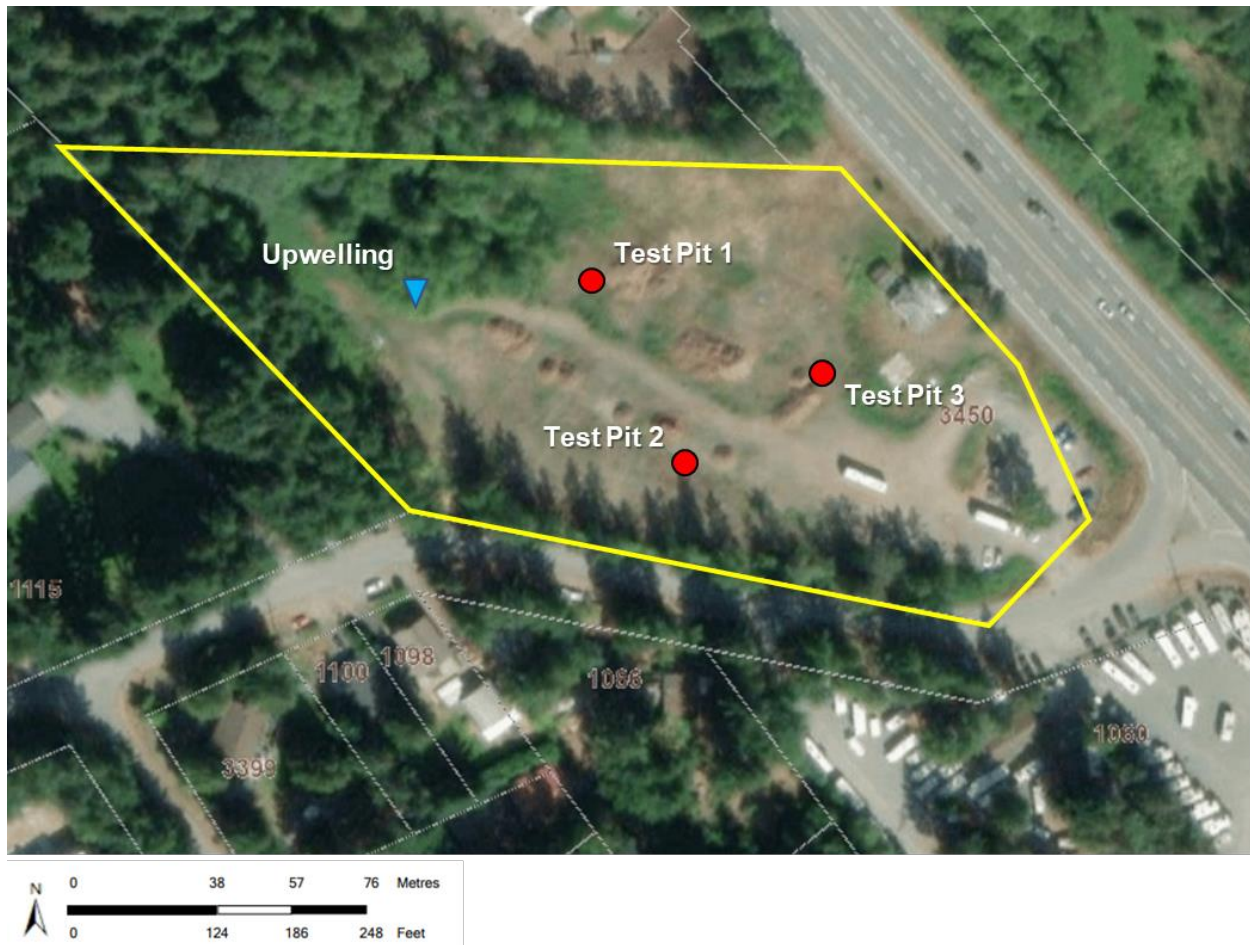
**FIGURE 1. AERIAL VIEW OF 3450 TRANS CANADA HIGHWAY (OUTLINED IN YELLOW). THE LOCATIONS OF THE TEST PITS EXCAVATED FOR MADRONE ENVIRONMENTAL SERVICES' ASSESSMENT TO INFORM AN AQUIFER PROTECTION PLAN AS RED PLACEMARKS. THE LOCATION OF GROUNDWATER UPWELLING INTO A SMALL POOND OBSERVED BY MADRONE IS MARKED. IMAGERY PROVIDED BY THE COWICHAN VALLEY REGIONAL DISTRICT (WORLD VIEW).**

The Property is located at the intersection of Trans-Canada Highway and Chapman Road, in the Cobble Hill area, ~15 km south of Duncan (**Figure 1**). According to CVRD mapping<sup>2</sup>, the Property covers an area of 1.9 ha (4.8 acres). The Trans-Canada Highway borders the Property along the west boundary, and Chapman Road borders its southern boundary. The Property is currently zoned Rural Residential 2 (RR-2) and is in a mixed-use area with nearby parcels being zoned for agriculture (A1), commercial and mixed use (C-3) and comprehensive development (CD-3). Satellite imagery (World View) provided on the CVRD mapping tool shows that the Property has been mostly cleared, with sparse forested areas existing only on the western side of the parcel, and along the southern parcel boundary. A large unpaved parking area is visible in the southern portion of the Property with an unoccupied building north of this parking area. Main access to the Property is from Chapman Road via a gravel driveway on the southeast side of the parcel.

No groundwater discharge information for the Property is available from the CVRD or the Province of British Columbia. During our field assessment (*3 Site Assessment*), Madrone observed a spring pooling into a small pond on the northwestern side of the Property which indicates the presence of upwelling groundwater (**Figure 1**; *Appendix A*).

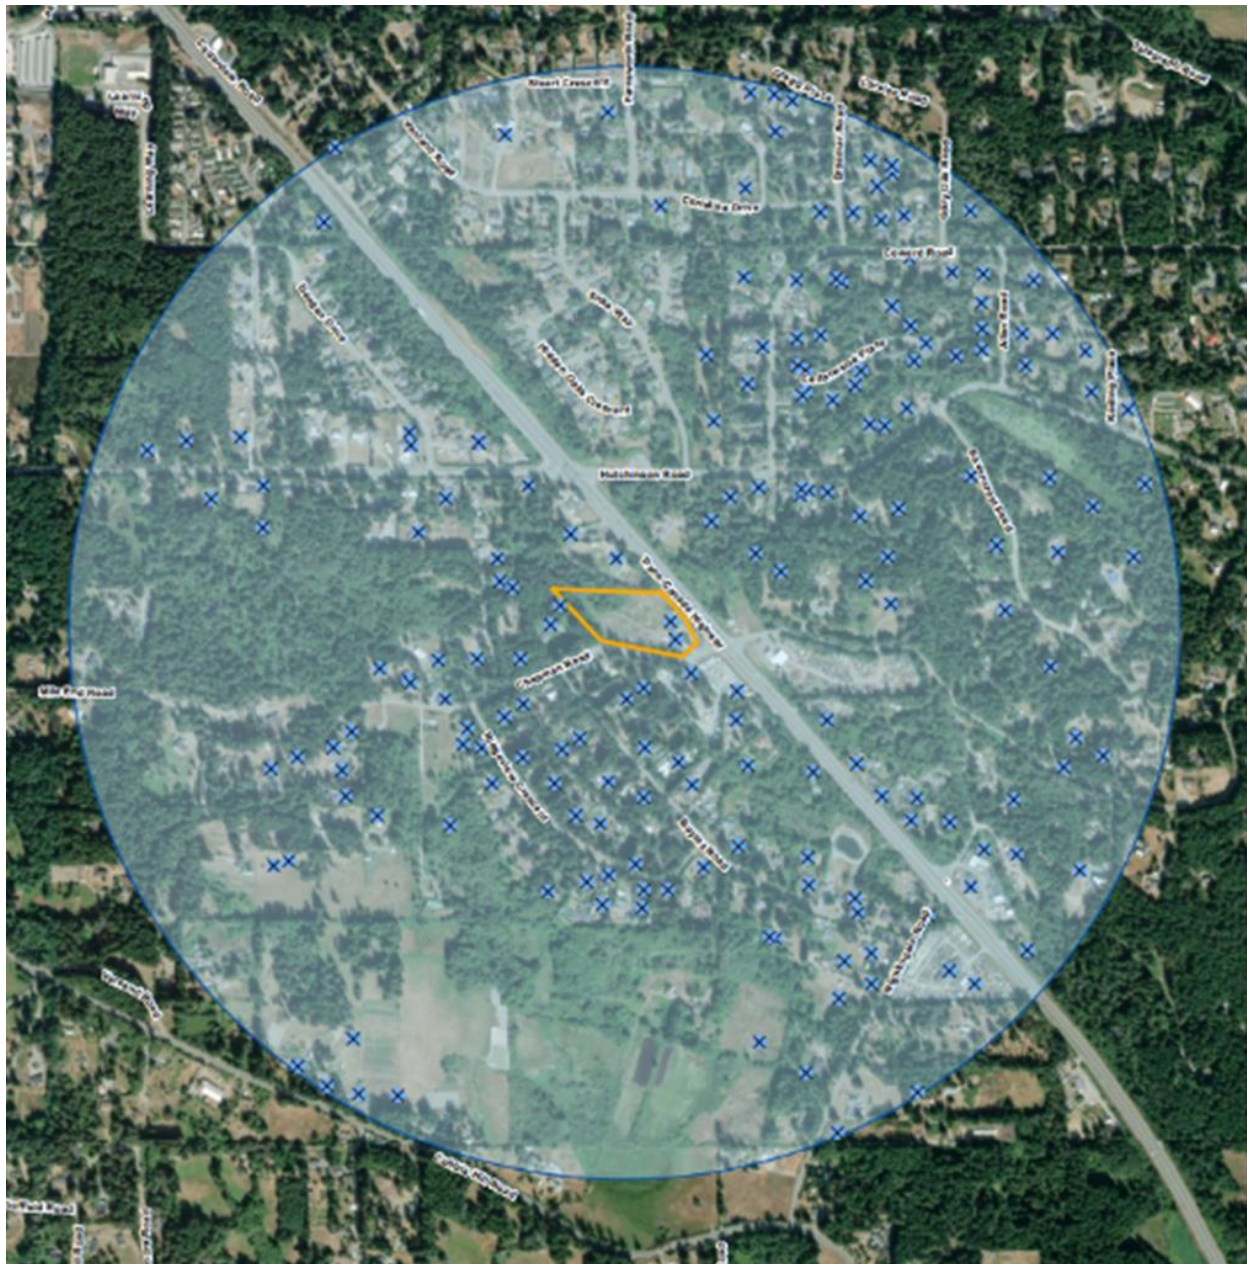
**FIGURE 2. GROUNDWATER WELLS WITHIN A 0.5KM RADIUS OF 3450 TRANS CANADA HIGHWAY (OUTLINED IN YELLOW). MAPPING PROVIDED BY THE PROVINCE OF BRITISH COLUMBIA.**

The BC Groundwater Wells and Aquifers Database<sup>9</sup> was used to identify registered wells in the vicinity of the Property. A search of the database identified ninety-two (92) existing registered water wells within 0.5 km from the perimeter of the Property (**Figure 2**; Appendix A). Information related to these wells is summarized in *Appendix B*.

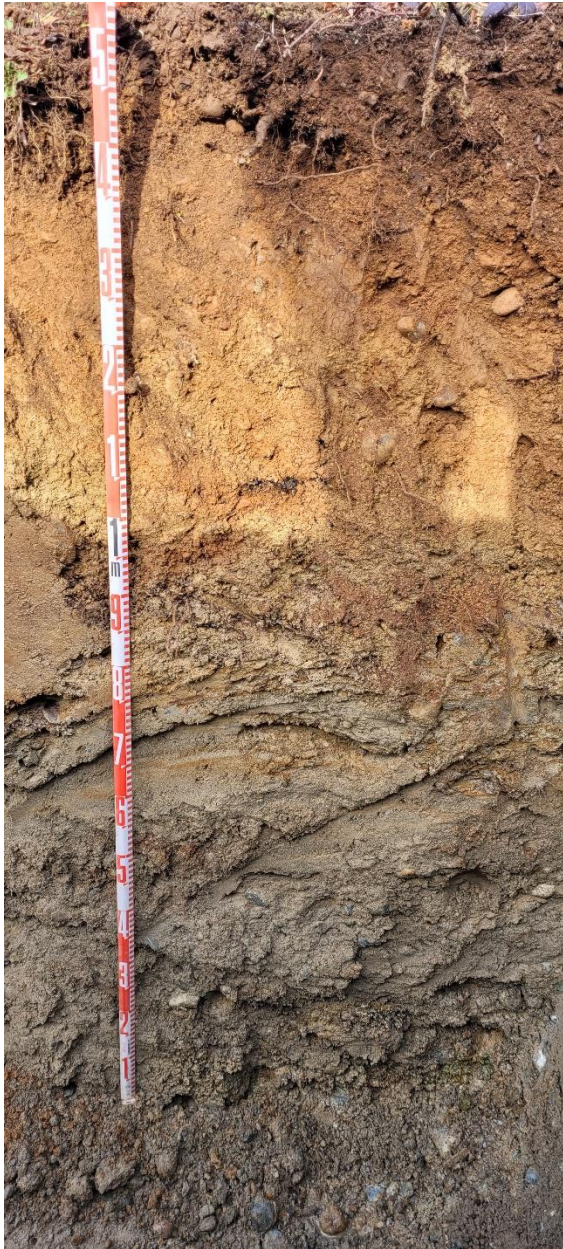
TEST PIT 1 (Photo 1; *Appendix C*) and TEST PIT 2 (Photo 2; *Appendix C*) were observed by Madrone to contain alternating layers of firm to very firm and compact sandy silt to sand, with variable coarse fragment contents between 5 to 40% (gravel to cobble range and generally subrounded to rounded. In TEST PIT 1, mottles and seepage were observed at a depth of ~100 cm. Observations of TEST PIT 3 (Photo 3; *Appendix C*) indicate that the lithology here is homogenous from a depth of 5 to 155 cm below ground, characterized by a firm to very firm and compact silt and sand matrix, and 10 to 15% coarse fragment content (pebble to cobble range; subangular to subrounded). Mottles were observed between 30 to 110 cm.

**PHOTO 1. PROFILE OF TEST PIT 1 EXCAVATED TO INFORM THE AQUIFER PROTECTION PLAN DEVELOPED BY MADRONE ENVIRONMENTAL SERVICES. PHOTO DATED FEBRUARY 22, 2023.**

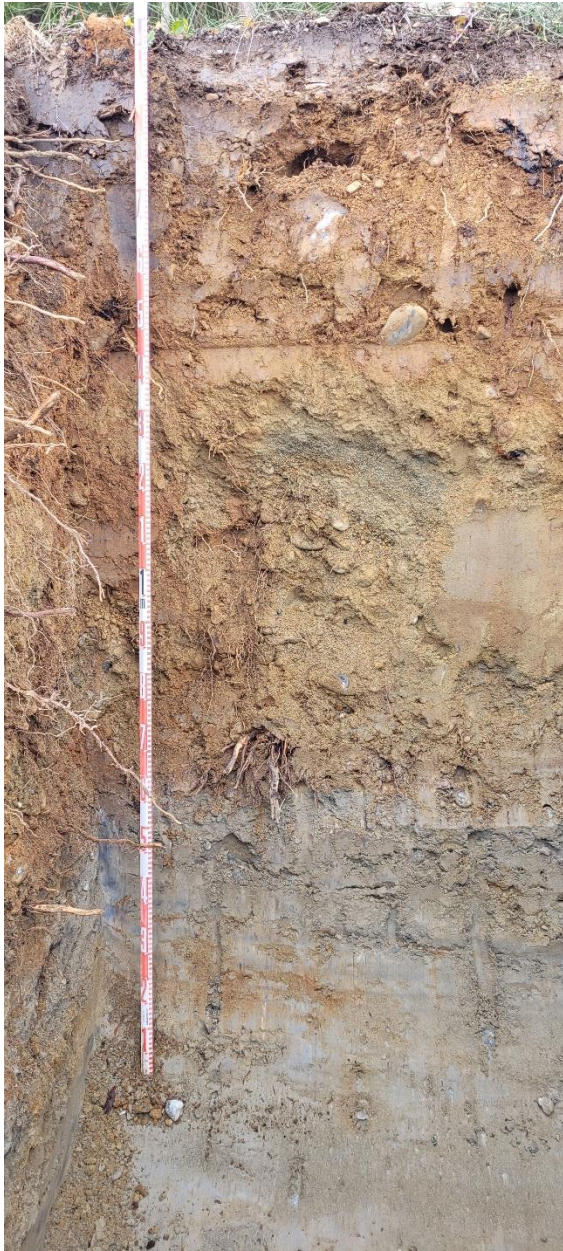
**PHOTO 2. PROFILE OF TEST PIT 2 EXCAVATED TO INFORM THE AQUIFER PROTECTION PLAN DEVELOPED BY MADRONE ENVIRONMENTAL SERVICES. PHOTO DATED FEBRUARY 22, 2023.**

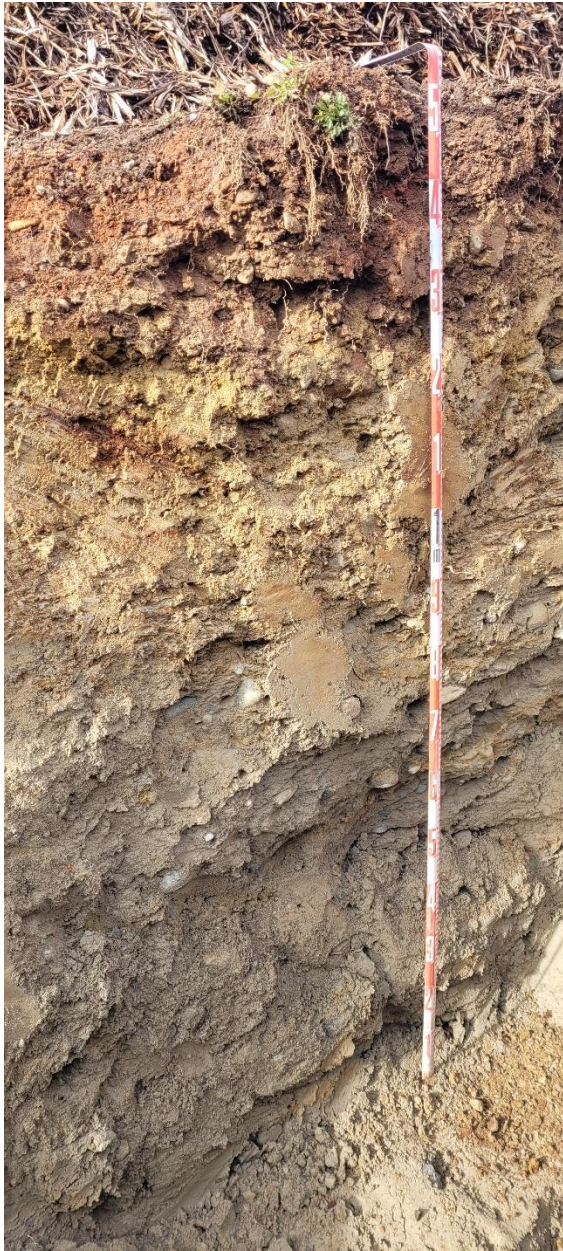
**PHOTO 3. PROFILE OF TEST PIT 3 EXCAVATED TO INFORM THE AQUIFER PROTECTION PLAN DEVELOPED BY MADRONE ENVIRONMENTAL SERVICES. PHOTO DATED FEBRUARY 22, 2023.**

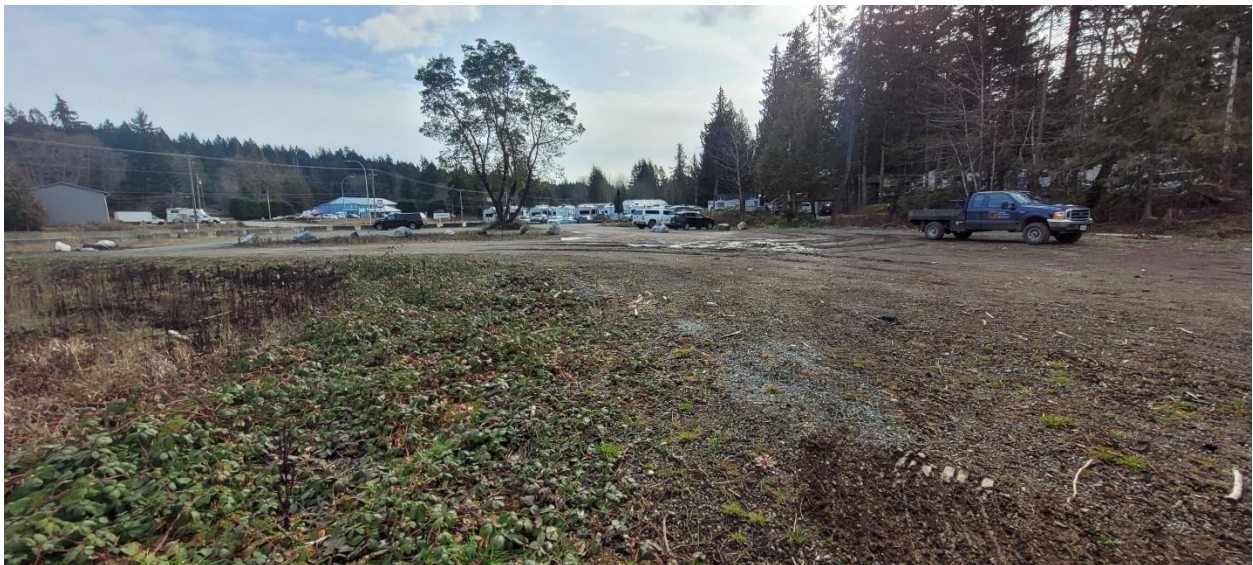
**PHOTO 4. VIEW STANDING ON THE NORTH SIDE OF THE PROPERTY LOOKING EAST. TEST PIT 1 IS SHOWN IN THE FOREGROUND. PHOTO DATED FEBRUARY 22, 2023.**

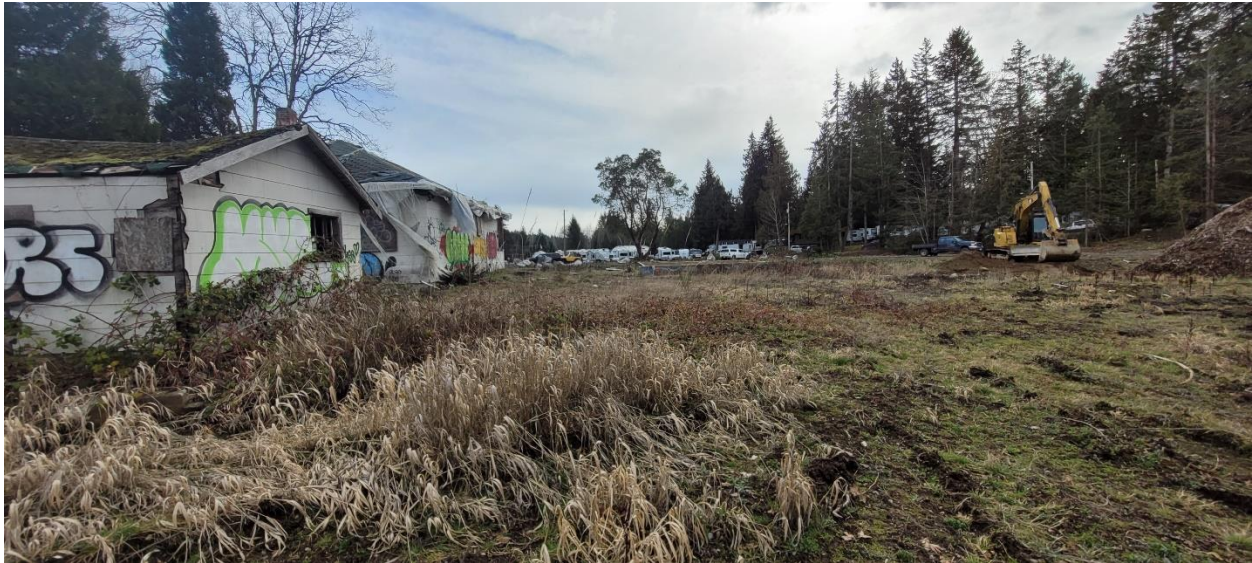
**PHOTO 7. VIEW STANDING ON THE EAST SIDE OF THE PROPERTY LOOKING NORTH. TEST PIT 3 IS SHOWN IN THE FOREGROUND. THE FORMER RESIDENCE IS SHOWN IN THE BACKGROUND. PHOTO DATED FEBRUARY 22, 2023.**

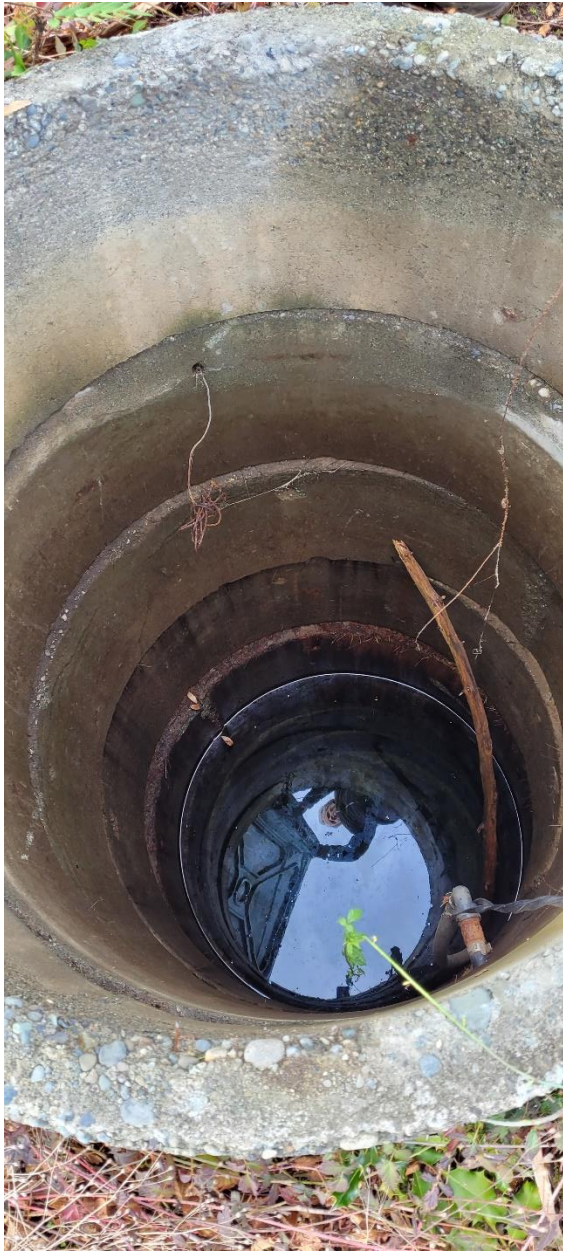
**PHOTO 10. VIEW LOOKING DOWN A GROUNDWATER WELL LOCATED PROXIMAL TO THE FORMER RESIDENCE. STATIC WATER LEVEL DURING THE TIME OF MADRONE'S ASSESSMENT WAS ESTIMATED TO BE ~ 1.5 M. PHOTO DATED FEBRUARY 22, 2023.**

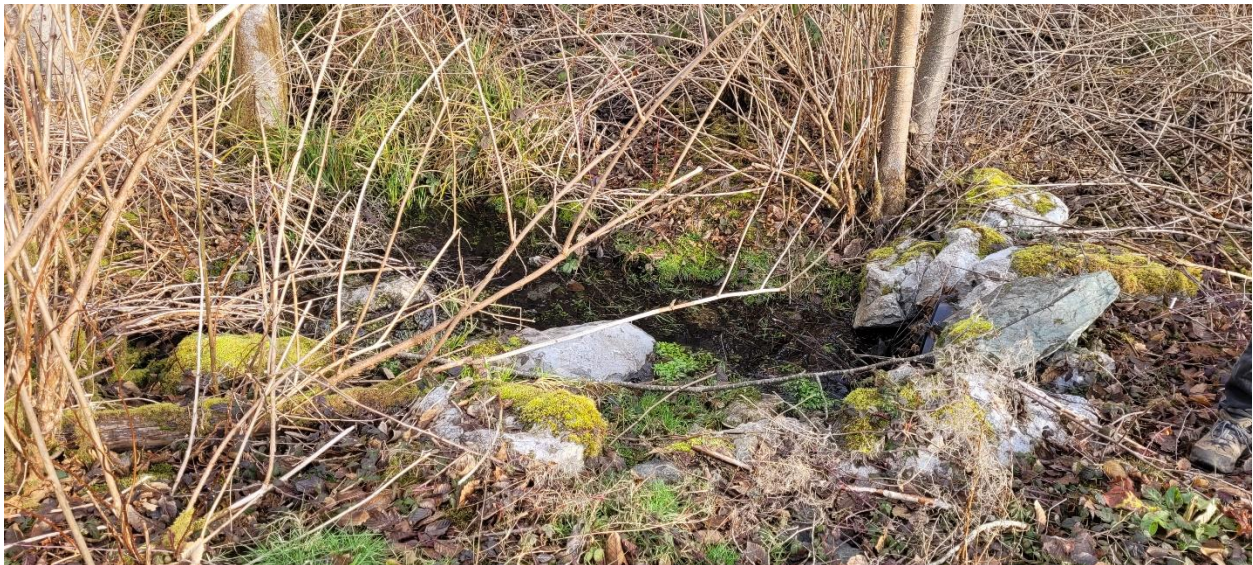
Madrone's observations of upwelling on the western side of the Property provides further evidence of infiltration to groundwater is likely to be attenuated due to a confining layer or layers. The upwelling is likely due to artesian conditions whereby there is a pressure difference caused by a perched, intermediate aquifer between confining layers.

**PHOTO 12. VIEW OF A SPRING POOLING INTO A SMALL POND ON THE NORTHWESTERN SIDE OF THE PROPERTY INDICATING THE PRESENCE OF UPWELLING GROUNDWATER. PHOTO DATED FEBRUARY 22, 2023.**

- 30 m buffer around pond and upwelling on the property;
- An emergency spill response kit is maintained and available for use on site;
- Regular inspection of vehicles on impermeable and permeable areas to detect and manage incipient leakage;
