**COWICHAN RIVER - RIVERBOTTOM  
ROAD AREA FLOOD AND EROSION  
HAZARD MAPPING**

**FINAL REPORT – REVISION 1**

Cowichan Valley Regional District  
Duncan, BC

NHC Ref. No. 3004940

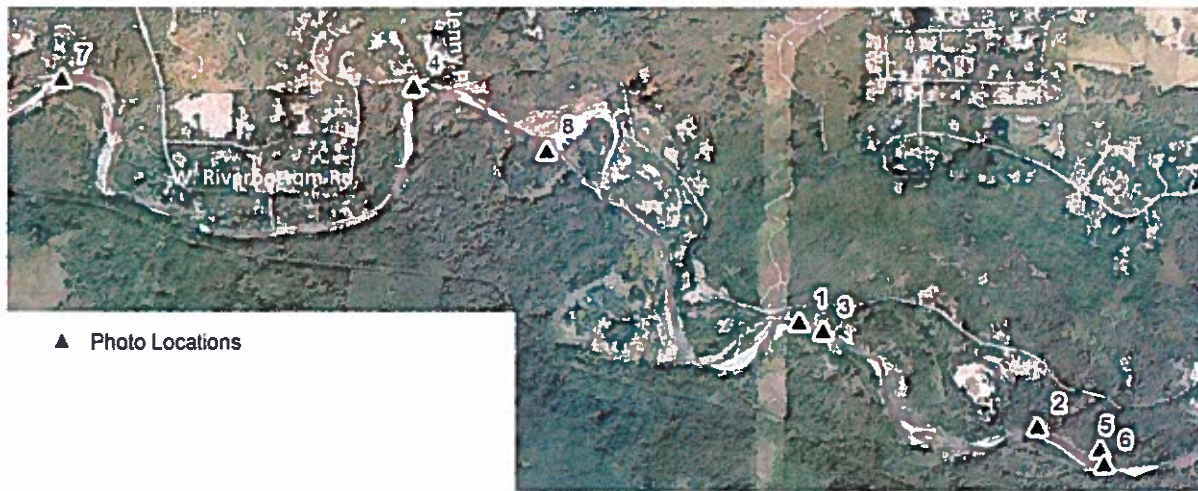
**Figure 3: Reference image showing approximate photo locations**

NHC completed a visit to the study reach on 1 February 2020 during the receding limb of the flood. Flood impacts were documented, and local residents provided useful insight into flood conditions on their properties. NHC also completed an assessment of changes to river morphology during the bathymetric survey (See Section 4.5). Key findings and observations from the site visit are summarized below. Photograph locations are referenced in Figure 3.

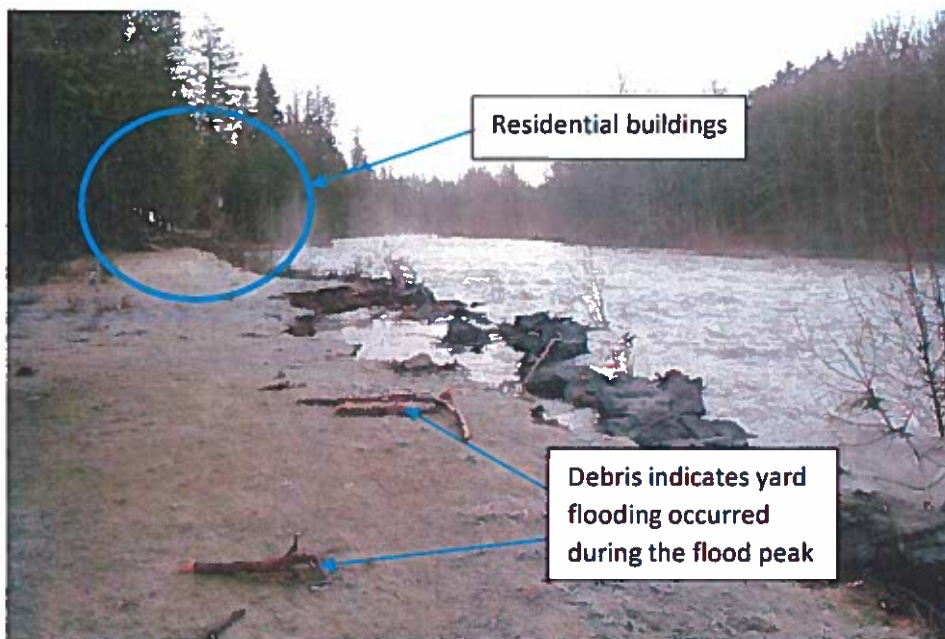
**Photo 1: Example of private property flooding on 1 February 2020. Yard areas were flooded but water levels reached few buildings. Riprap revetments were overtopped, resulting in bank washout**

- Bank protection works, such as riprap revetments, were overtopped and damaged at several locations (Photo 1, Photo 3, Photo 4).
- Sandy Pool Regional Park and Stoltz Pool Campground at Cowichan River Provincial Park were flooded (Photo 5, Photo 6). There was damage to the boat launch and trails at Sandy Pool. Bank erosion occurred throughout Stoltz Pool Campground and much of the study reach (Photo 7). Online advisories from BC Parks indicated that severe trail and footbridge washout occurred along the Cowichan Valley Trail and Cowichan River Footpath near the downstream end of the study reach at Holt Creek.

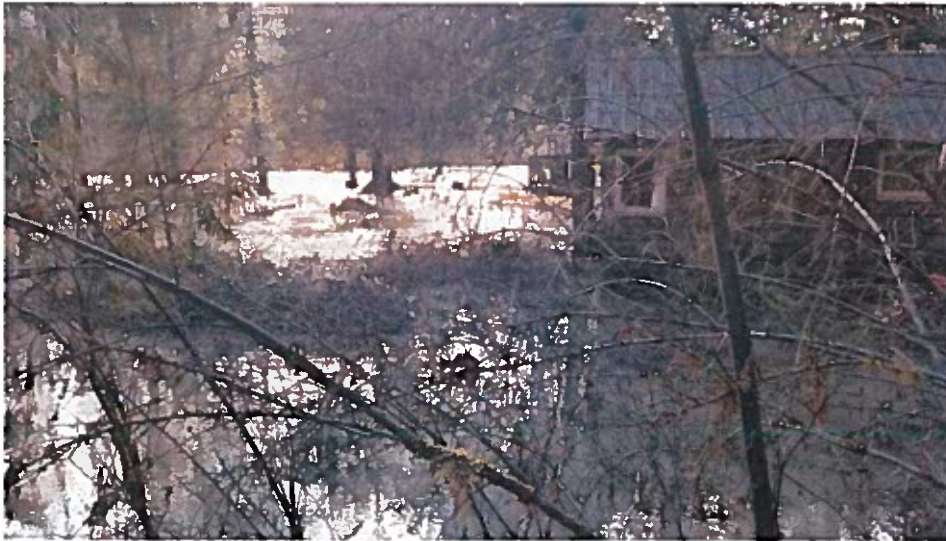
**Photo 2: Example of private property flooding on 1 February 2020 (Photo provided by CVRD).**

- Overbank flooding occurred at several riverfront properties (Photo 1). One house between Sandy Pool Regional Park and the Cowichan Bible Camp was flooded (Photo 2) with approximately half a foot of water (K.Miller, Pers. Comm.)

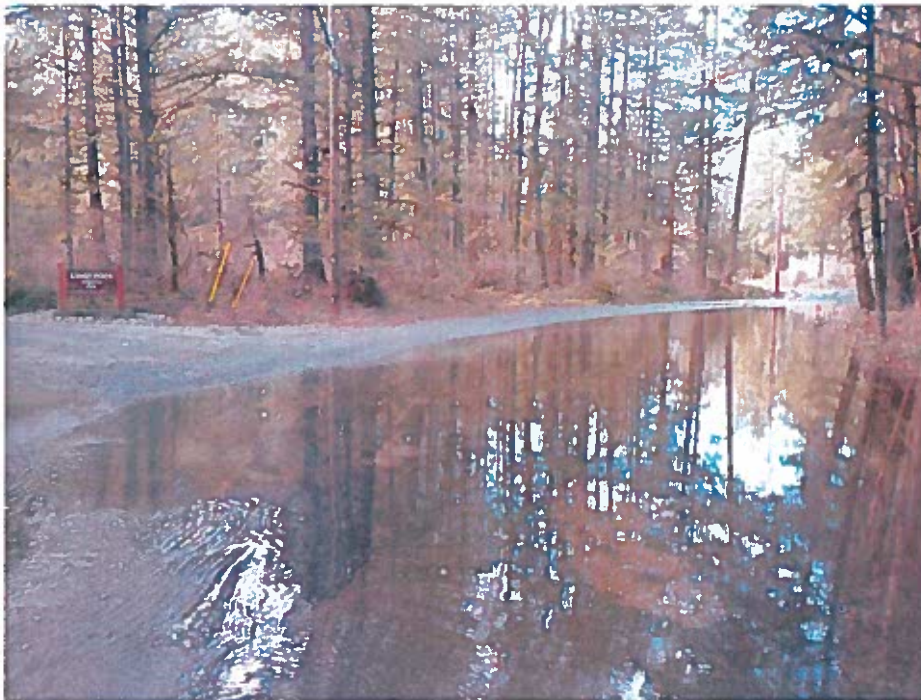
**Photo 5: Example of flooding at Sandy Pool Regional Park on 1 February 2020**

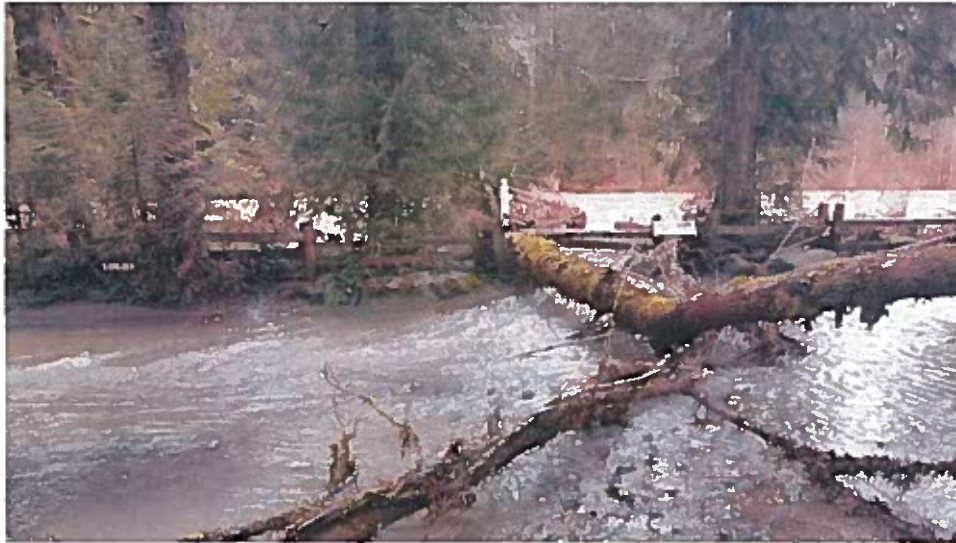
**Photo 6: Overbank flow through Sandy Pool Regional Park on 1 February 2020 (Photo provided by CVRD)**

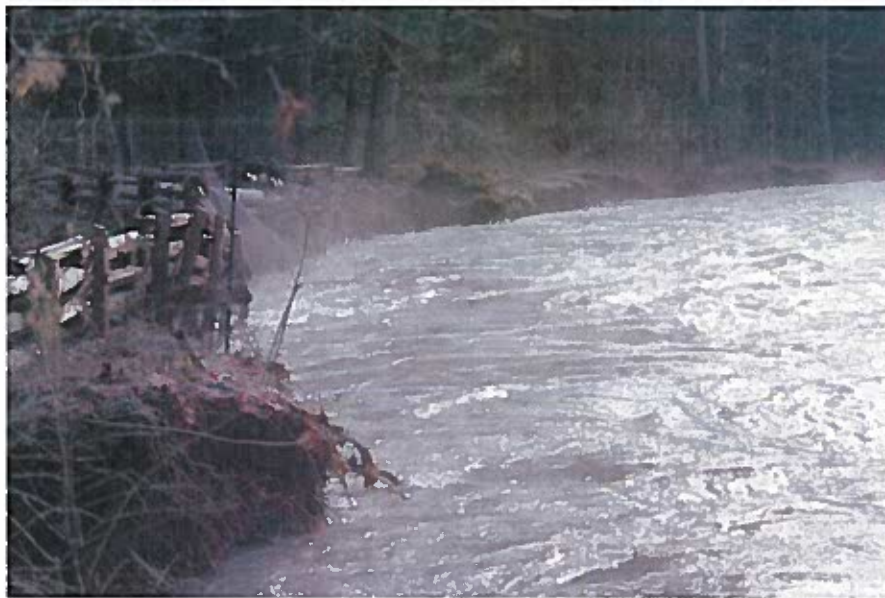
**Photo 7: Example of bank erosion at Stoltz Pool Campground on 1 February 2020**

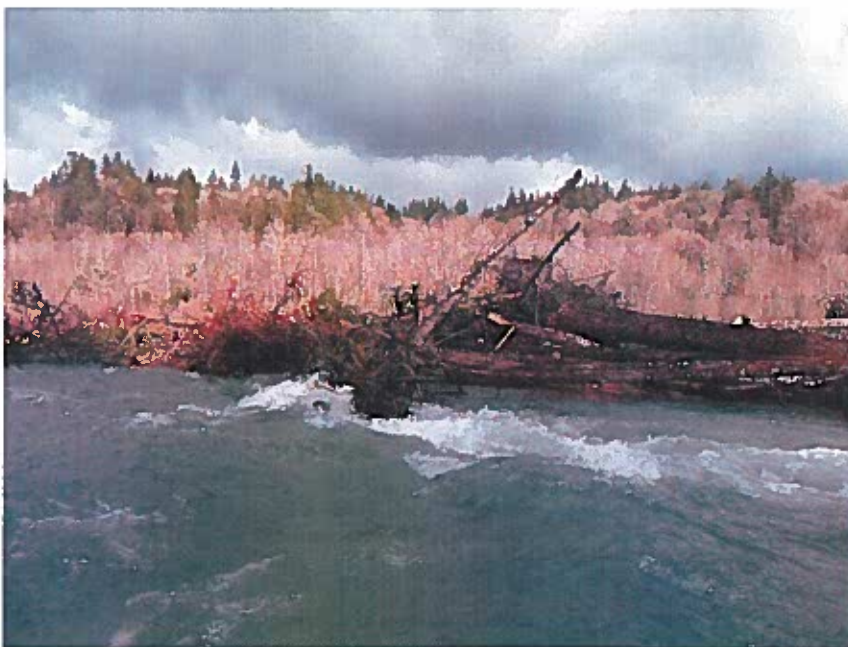
**Photo 8: Example of log jam on 18 February 2020; location is near the avulsion channel**

- Large volumes of wood debris and sediment were transported during the flood. Several log jams formed in the study reach (Photo 8).

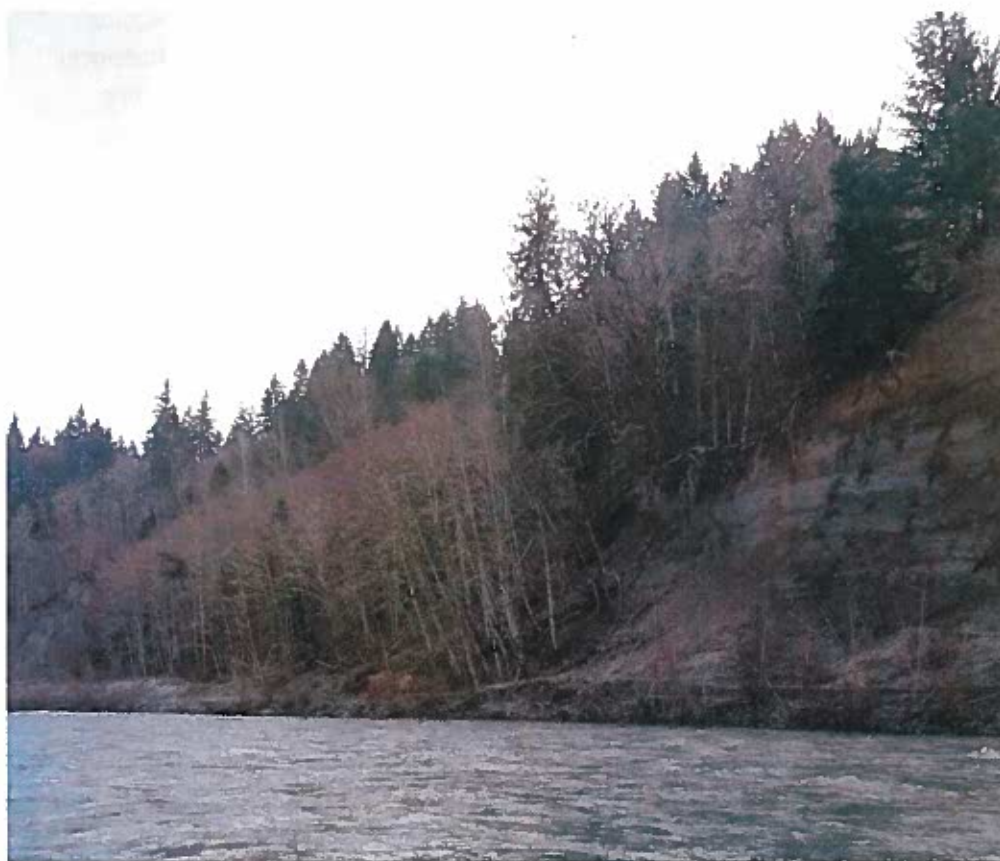
**Photo 9: View toward Stoltz Bluff and exposed Quadra sediments**

Quadra sediments are a fluvial and glaciofluvial material comprised of interbedded layers of sand, gravel, silt, and clay, likely deposited in front of the advancing glacier. Quadra sediments are located along the upper half of the study reach along the north side of the channel, including Stoltz bluff (Photo 9). Vashon drift sediments are more recent deposits comprised of glaciofluvial, glaciolacustrine and till. These deposits are mapped along the southern valley wall and are exposed at several locations along the south side of the channel. Haslam Formation refers to a type of bedrock exposed in several locations along the lower half of the study reach. Bedrock exposures along the channel margin were identified and mapped with a handheld GPS during the geomorphic assessment.
